Manhole Inspection Summary

Manhole # **S15C__018MH**

Insp Date: **11/29/07 11:40 AM**

Location Address: **SIDE 600 WHITMORE**

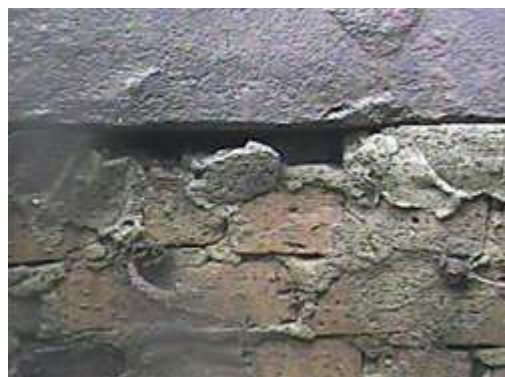
Defect 1

Count: **5** Missing: **1** ☒ **Corroded**

MISSING CORRODED RUNG

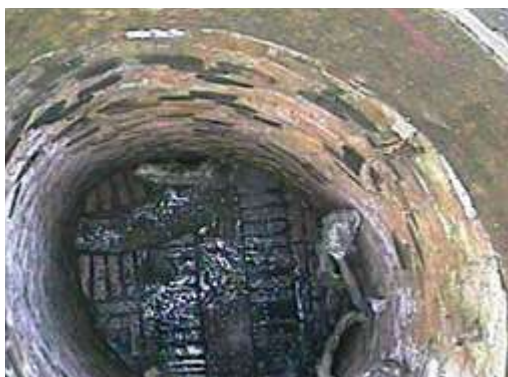
Defect 2

☒ **Evidence Of Surcharge** Depth: **3** (ft.) ☐ Active Surcharge Present

EVIDENCE SURCHARGE

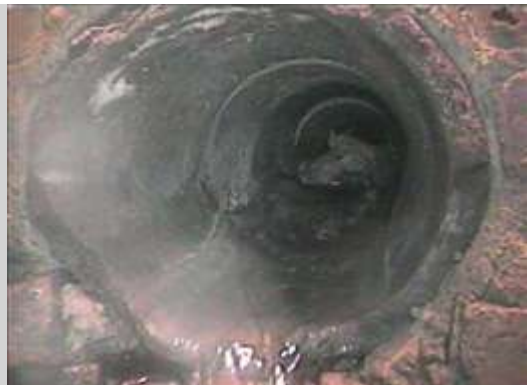
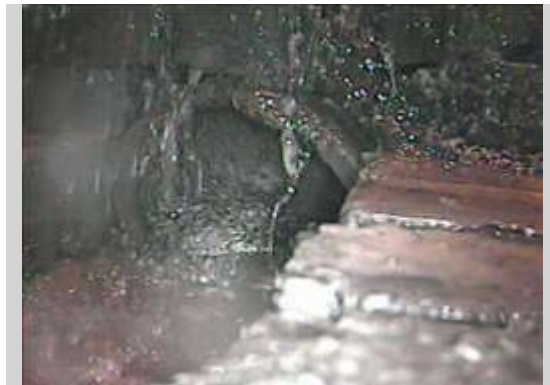
6 O'Clock Inflow

Pipe Height: (in.) Direct
Pipe Material: **Clay** ☐ Pipe Lined
Invert Depth: **6.14** (ft.) Flow Characteristics: **Slow**
Deposits: ☐ None ☒ Mud ☒ Sludge ☒ Debris ☒ Grease
Silt Depth: **8** (in.) Deposits Extent: **Heavy**
Infiltration: **None** Pipe Seal Cond: **Cracked**

Drop: **Outside Direct**
Angled: Reading: (ft.)
Inv Depth: **8.76** (ft.)
Drop Condition: **Clogged**
